Re: Black Hollow Debris Flow Preliminary Report

# Initial spot check of USGS debris-flow likelihood and volume models for the Cameron Peak burn area and the 20 July 2021 flow event

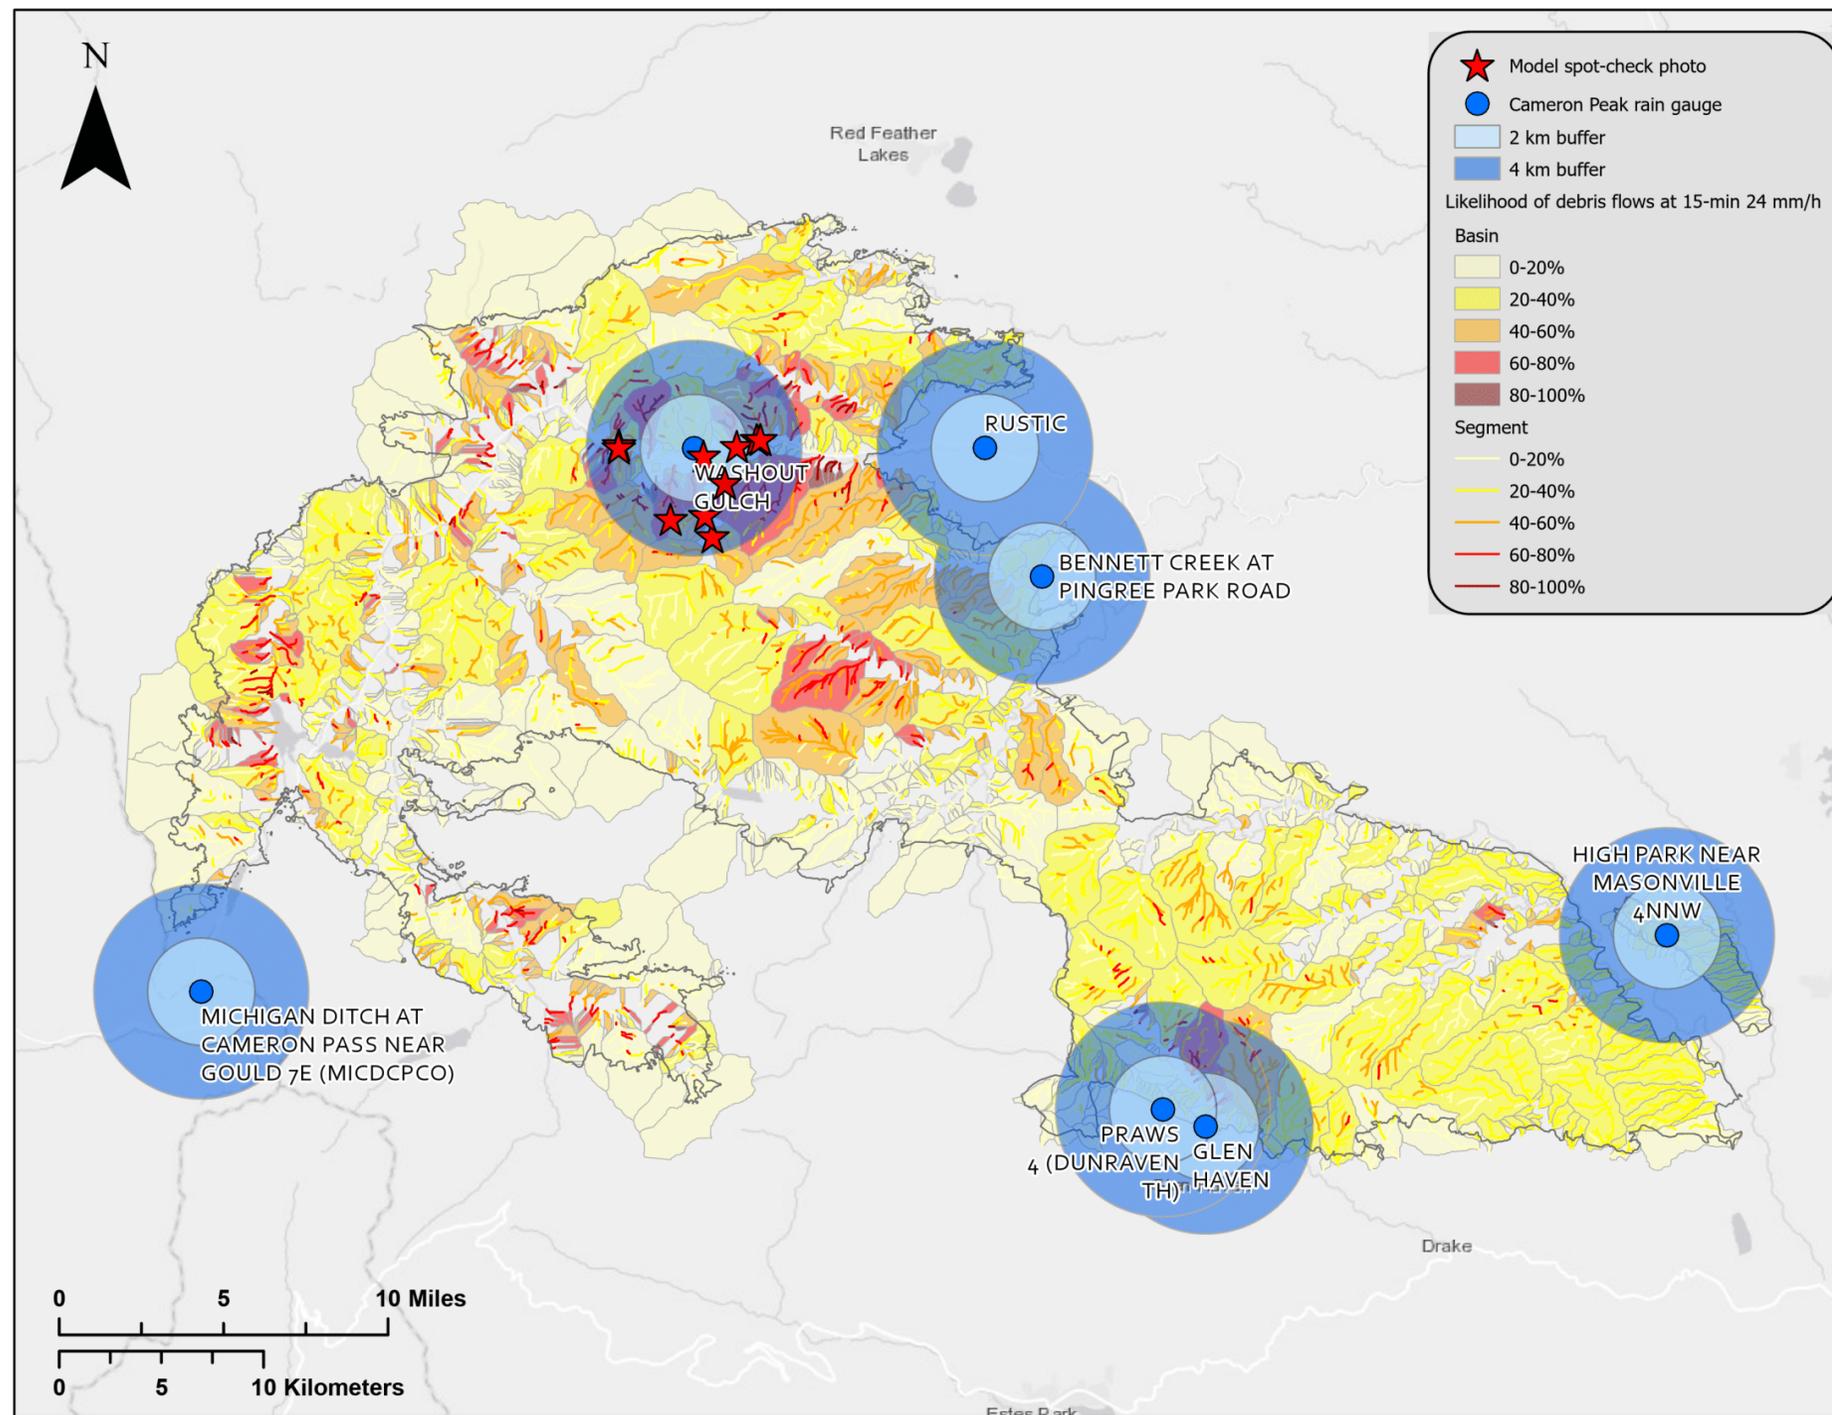
## Where was rainfall recorded?

We limit our analysis to an area within **4 km** of measured rainfall to reduce uncertainty in rates due to spatial variability of rainfall.

The Washout Gulch rain gage is presently the only known gage near our observations of flow activity in the Cameron Peak burn area.

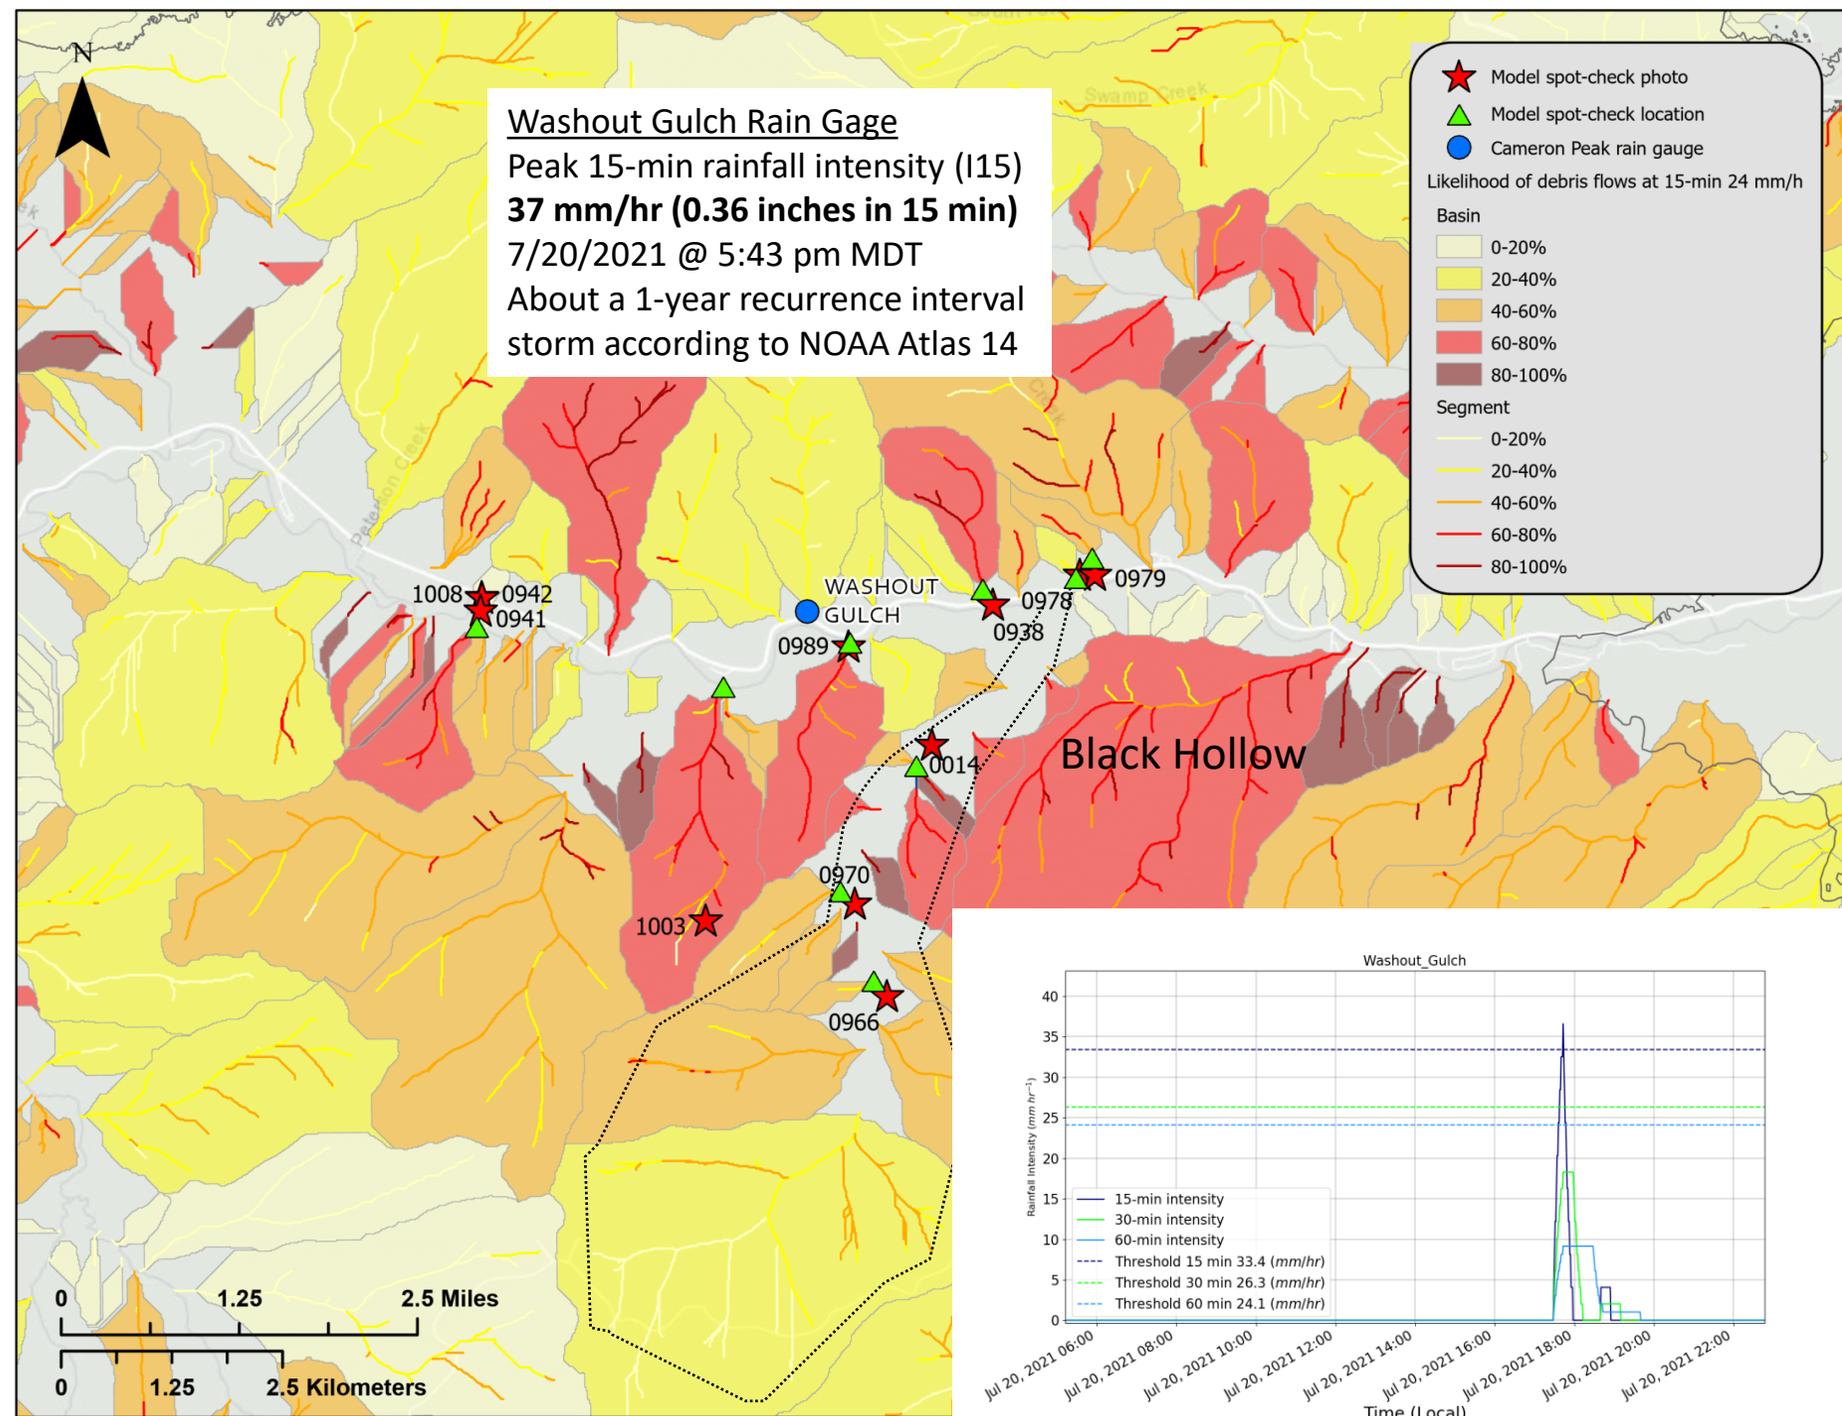
## Where was flow observed?

Flow activity was observed on the ground 7/22 and by helicopter 7/24.

We paired observations of significant flow with model predictions of debris-flow likelihood and volume using observed I15 of 37 mm/hr.

The outlet of Black Hollow is beyond the 8 km<sup>2</sup> limit of debris-flow model predictions; however, contributing basins were modeled.

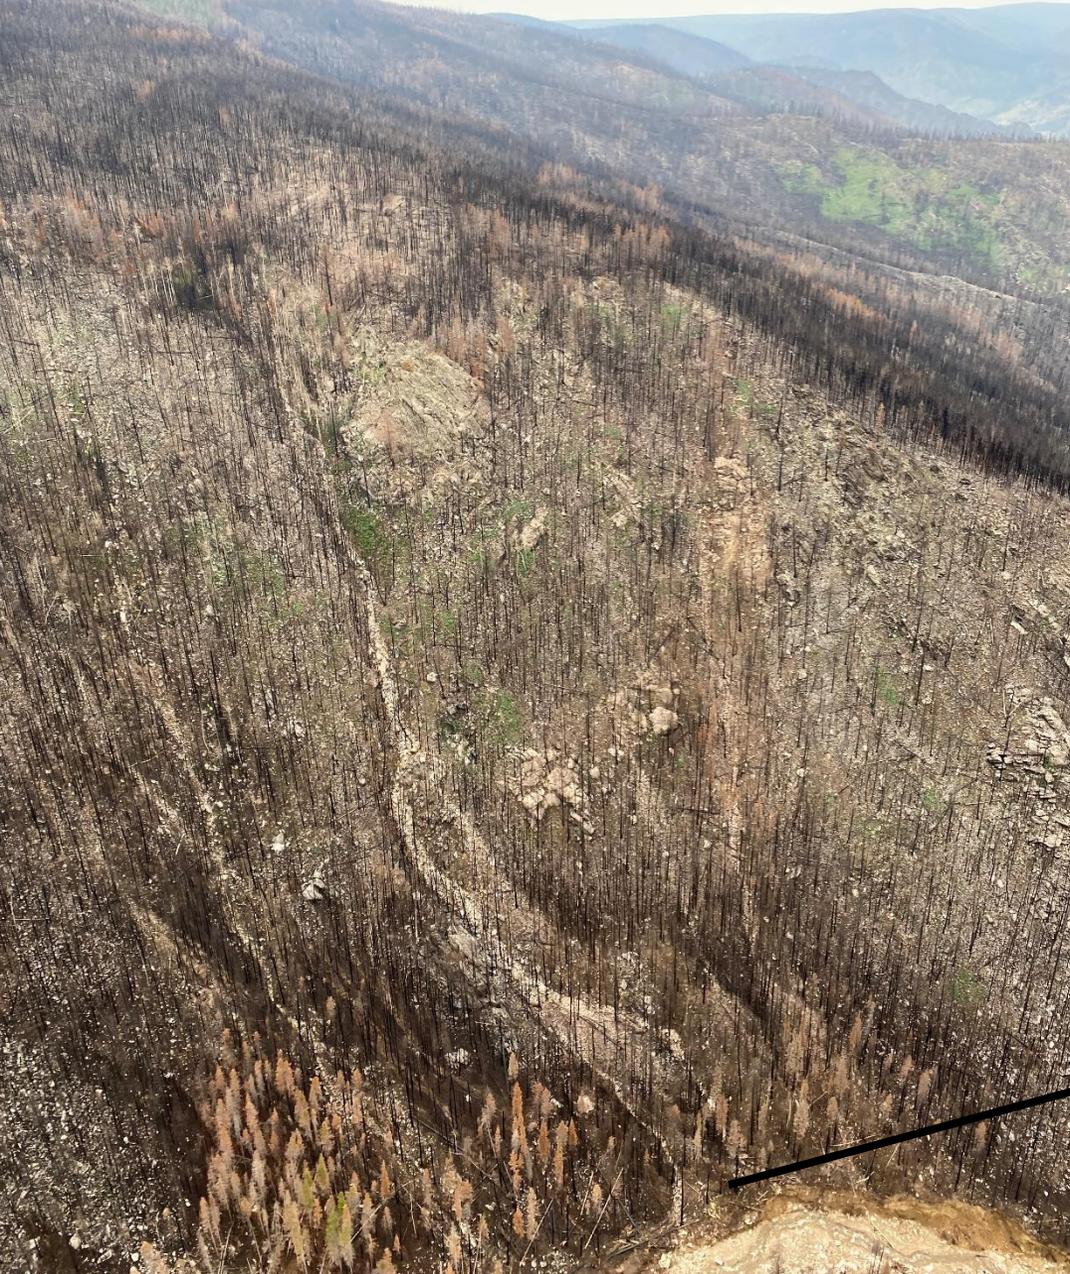
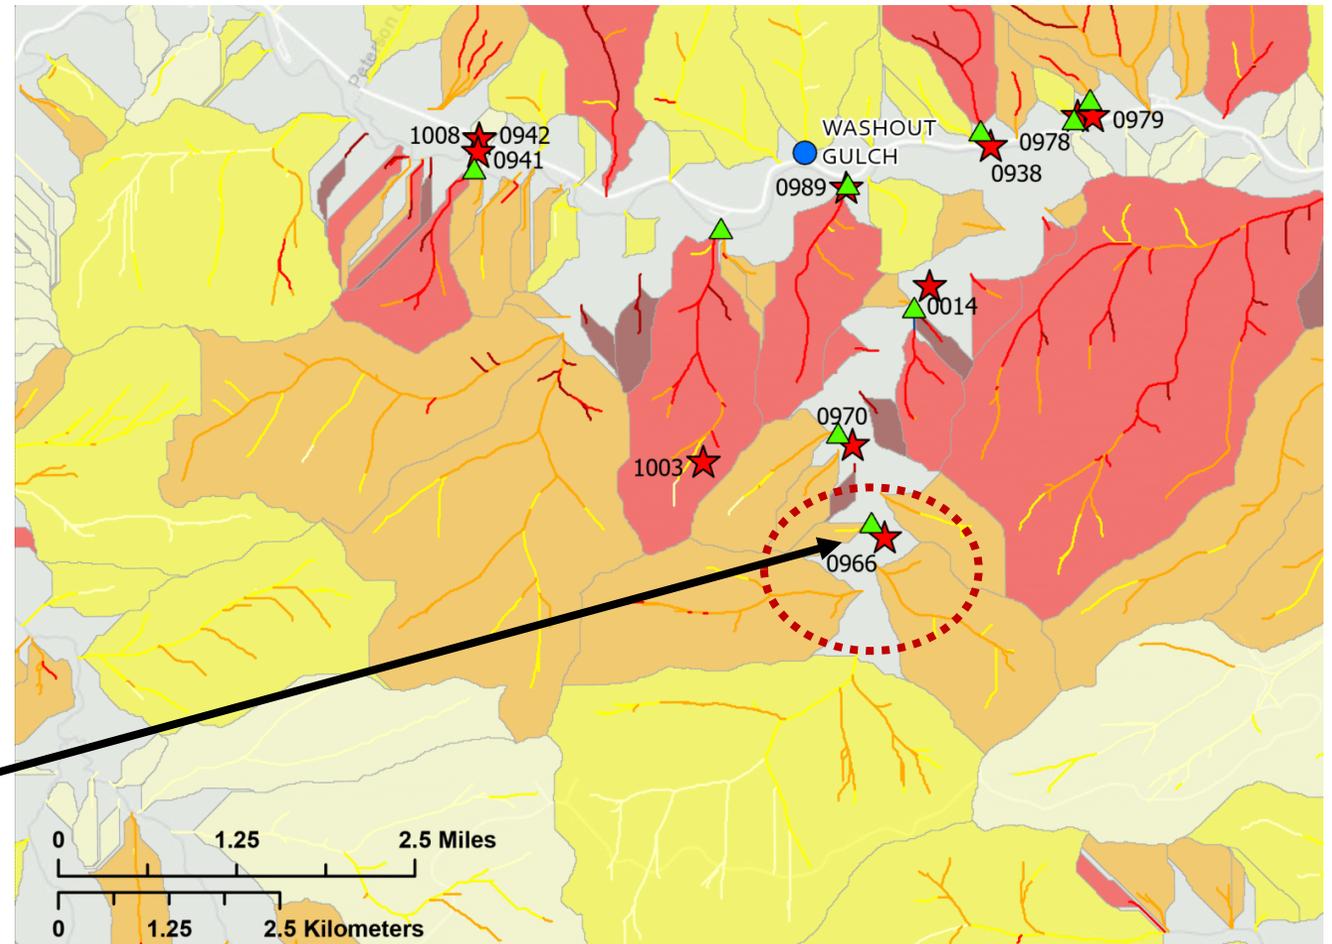
# Observation 0966

## Small side drainage in Black Hollow

Segment ID	Obs. I15 (mm/hr)	Likelihood (%)	Volume (m <sup>3</sup> )
7538	37	89	2,000

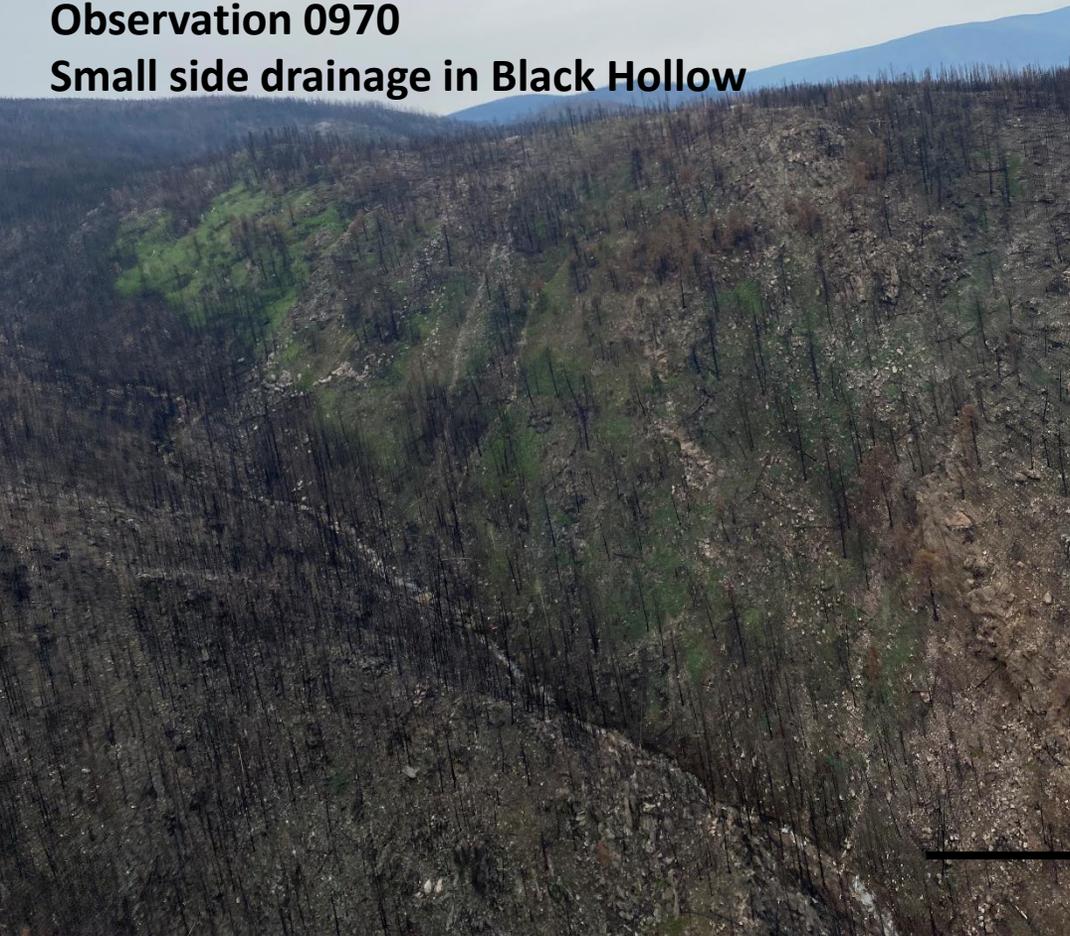
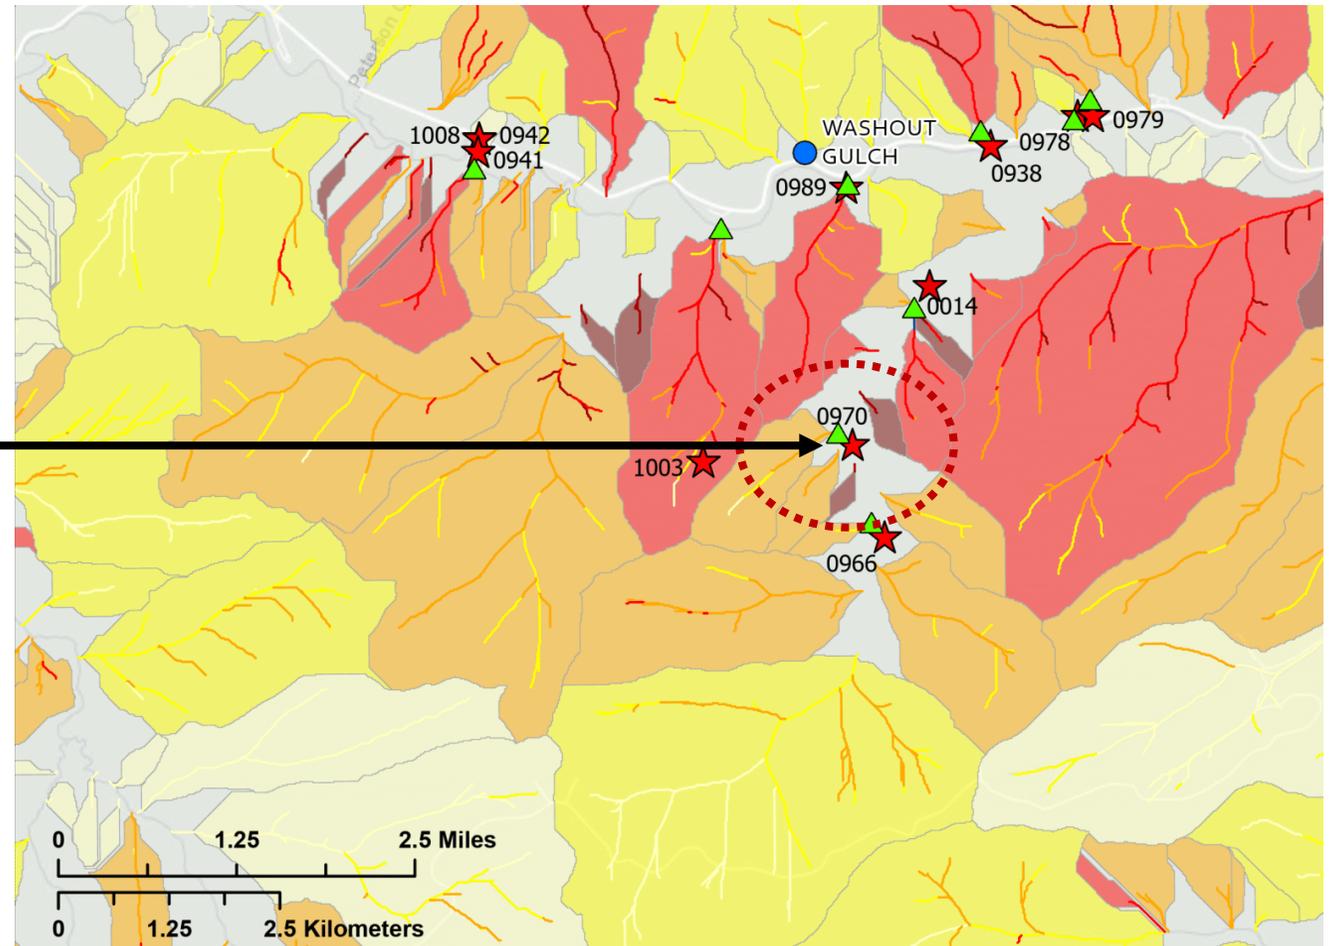
# Observation 0970

## Small side drainage in Black Hollow

Segment ID	Obs. I15 (mm/hr)	Likelihood (%)	Volume (m <sup>3</sup> )
6603	37	90	9,000

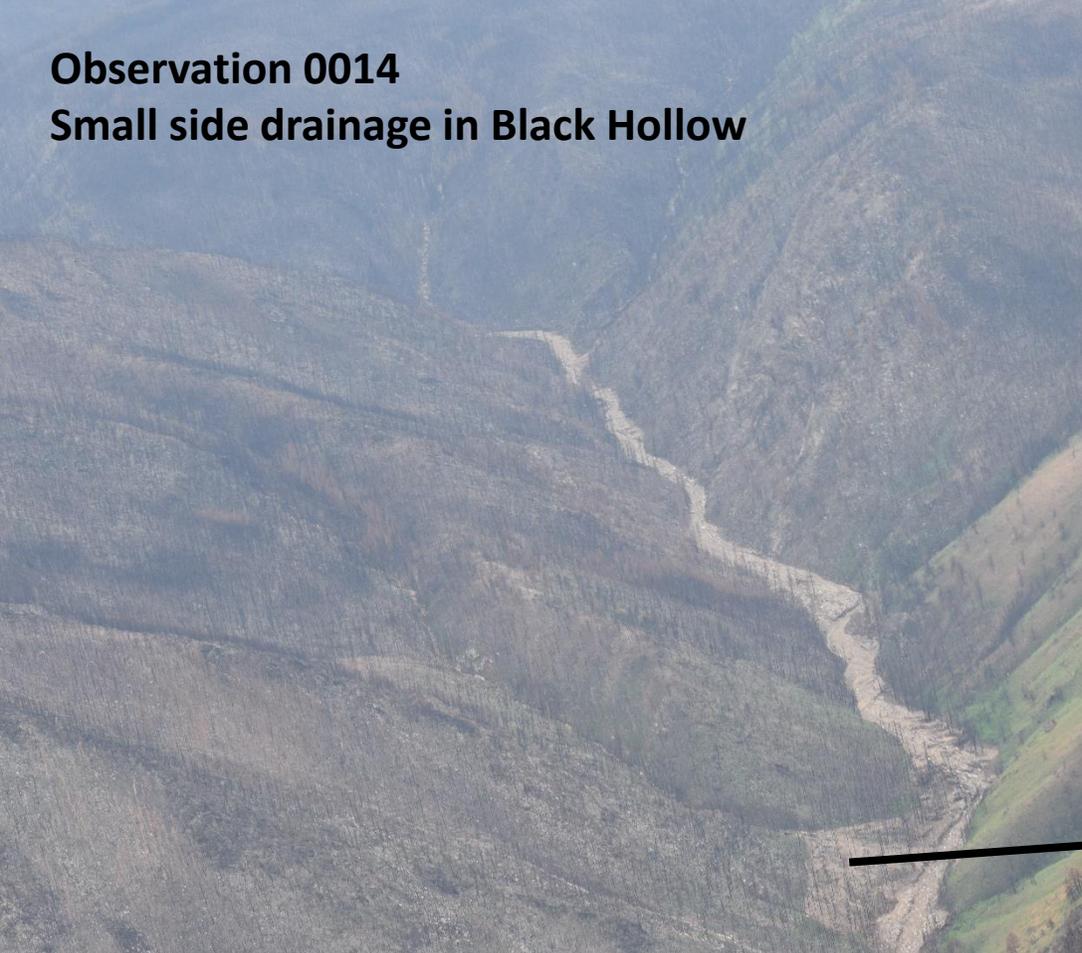
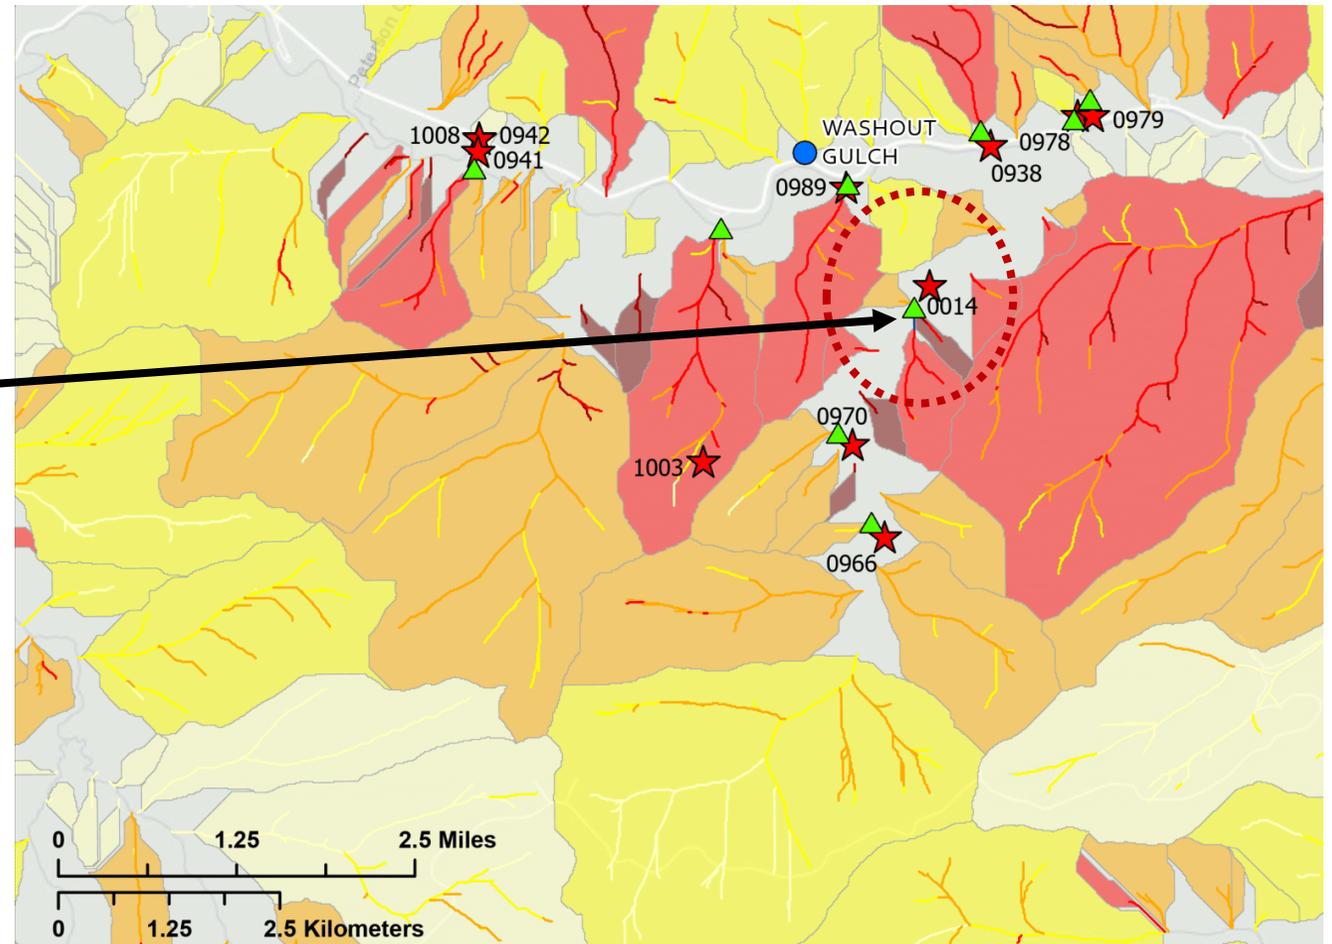
# Observation 0014

## Small side drainage in Black Hollow

Segment ID	Obs. I15 (mm/hr)	Likelihood (%)	Volume (m <sup>3</sup> )
5963	37	98	9000

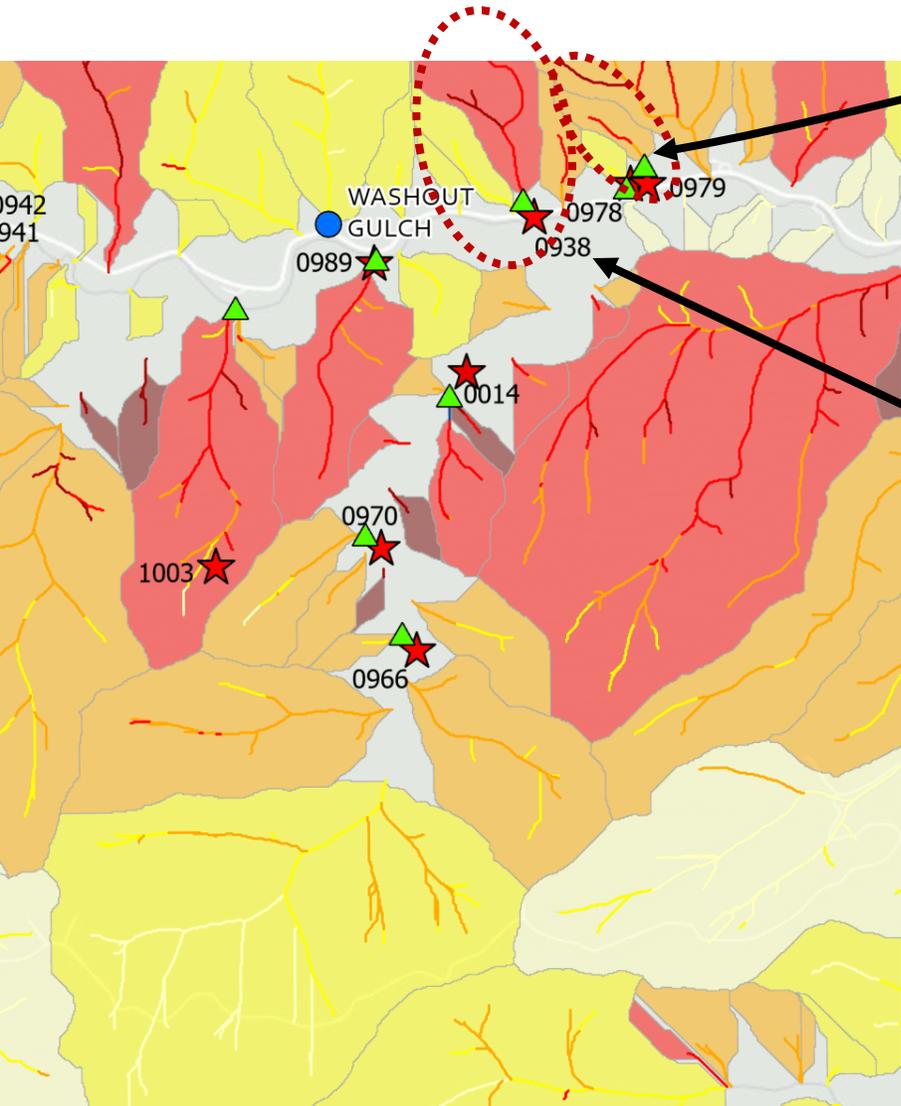
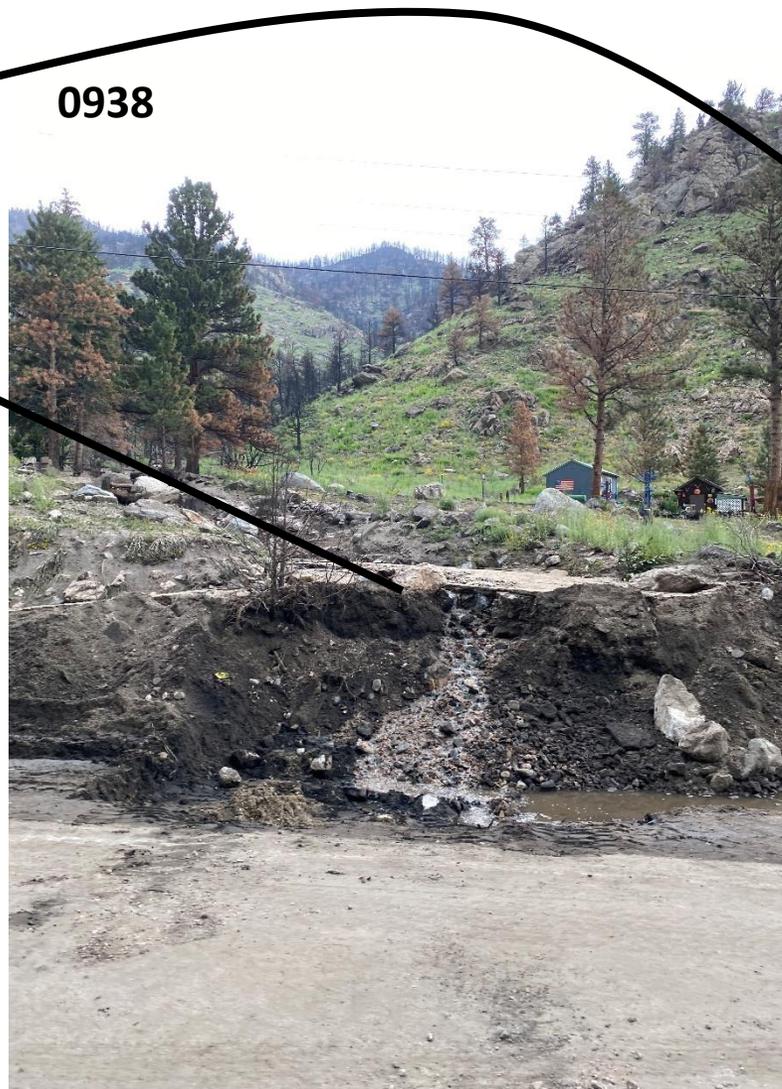
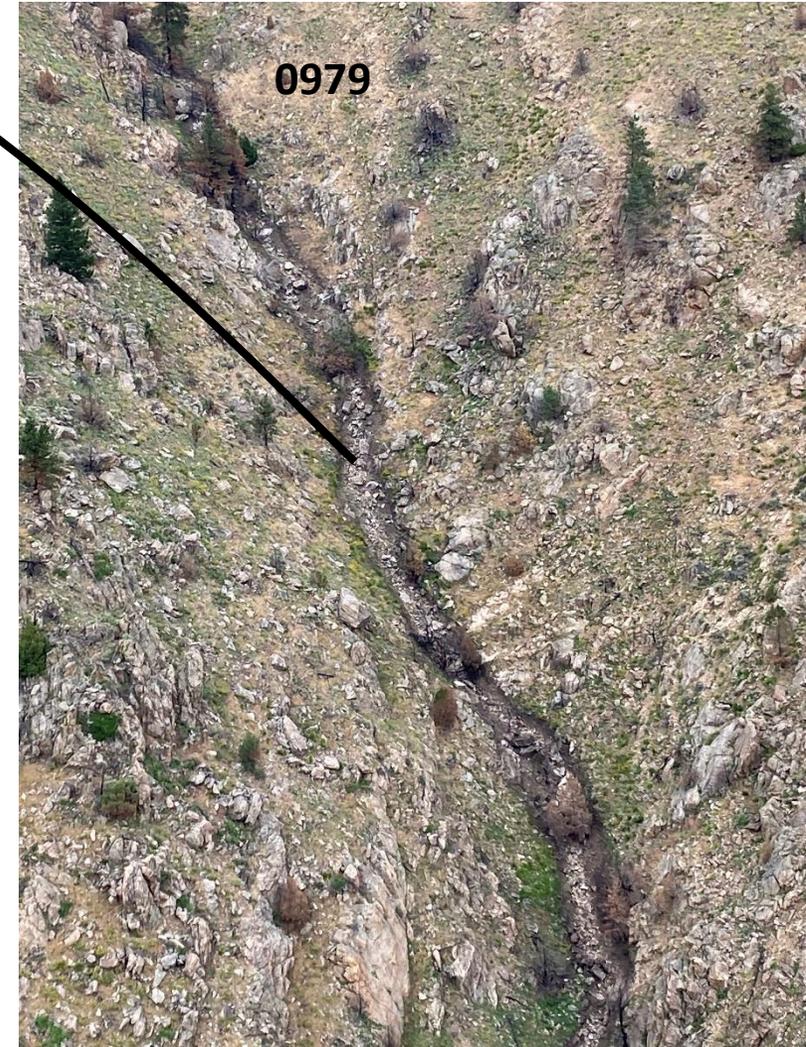
Obs. #	Segment ID	Obs. I15 (mm/hr)	Likelihood (%)	Volume (m <sup>3</sup> )
0938	4363	37	97	10,000
0979	4174	37	89	2,000

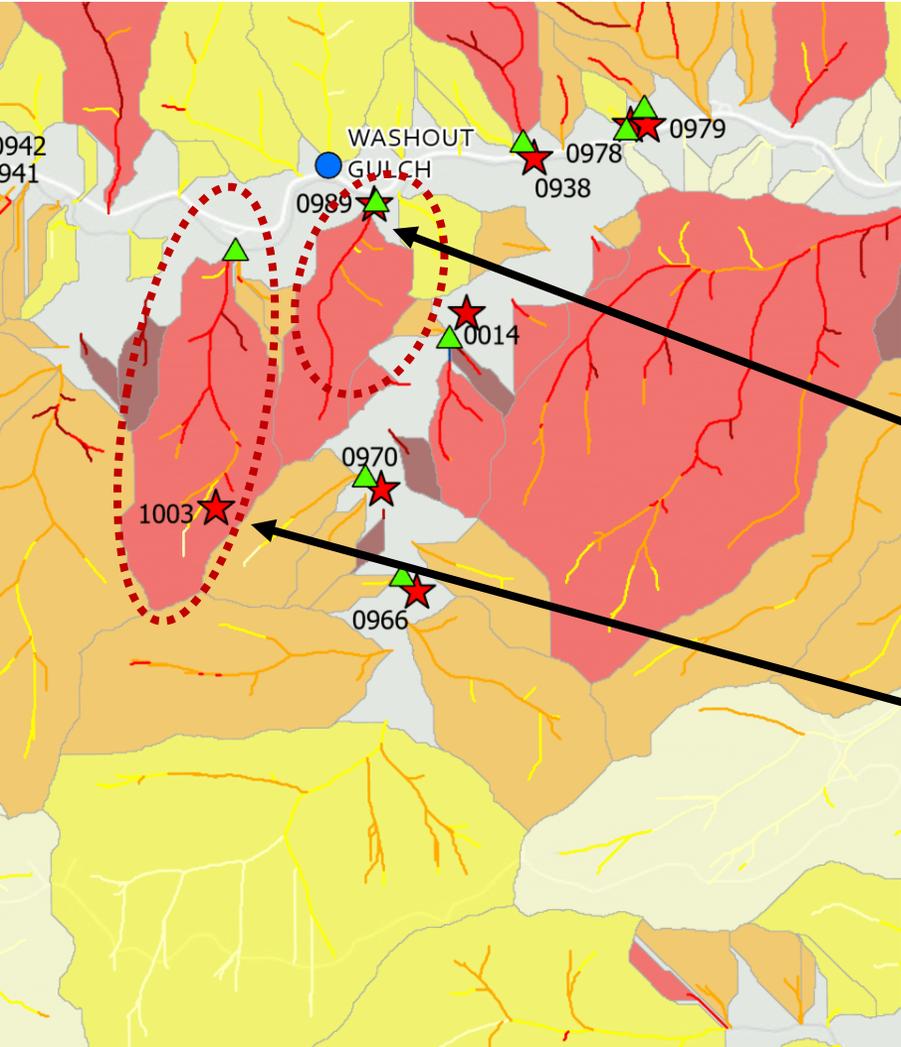
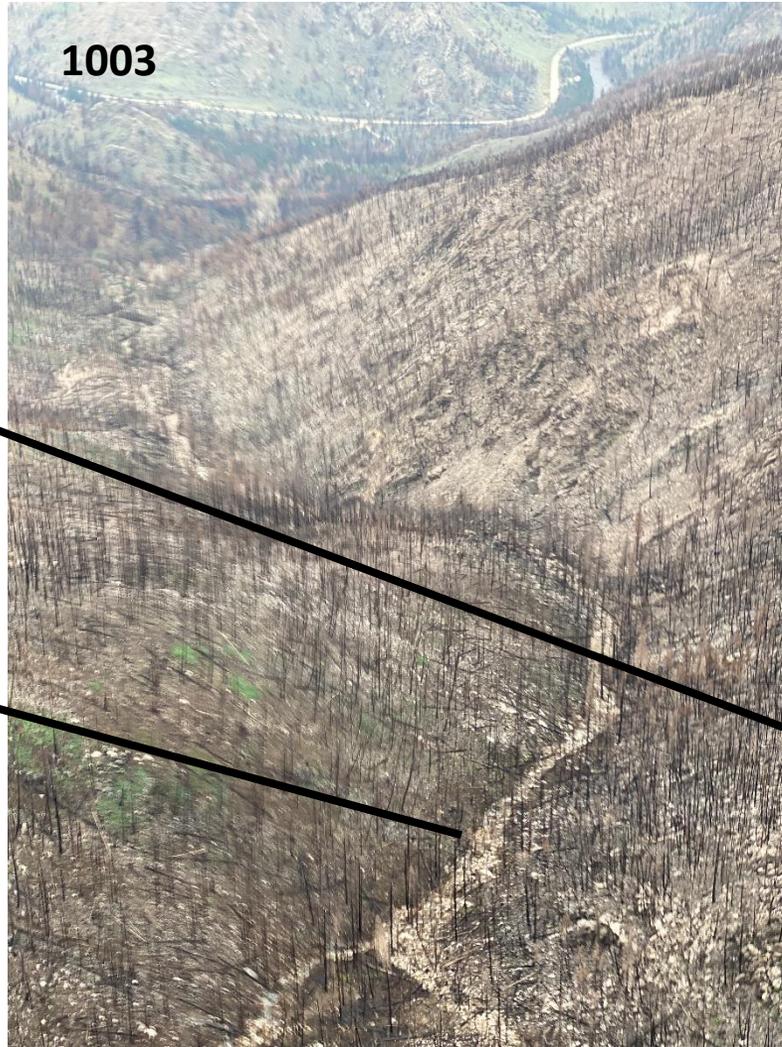
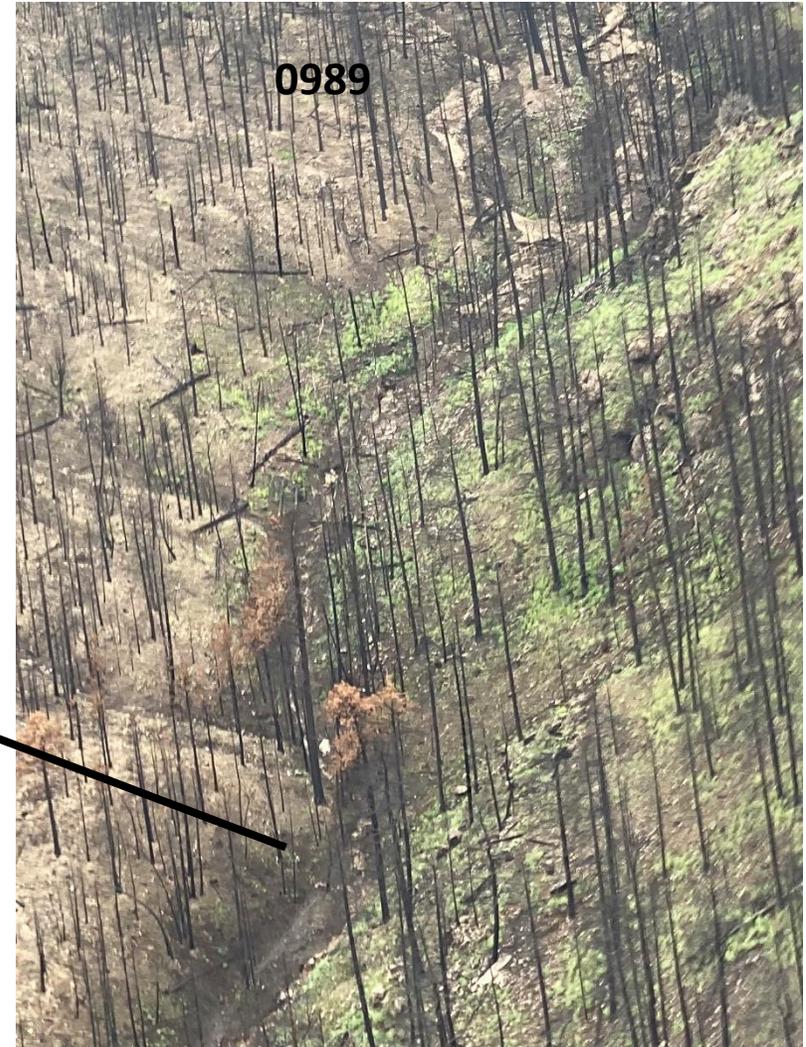
Obs. #	Segment ID	Obs. I15 (mm/hr)	Likelihood (%)	Volume (m <sup>3</sup> )
1003	4824	37	96	25,000
0989	4174	37	95	10000

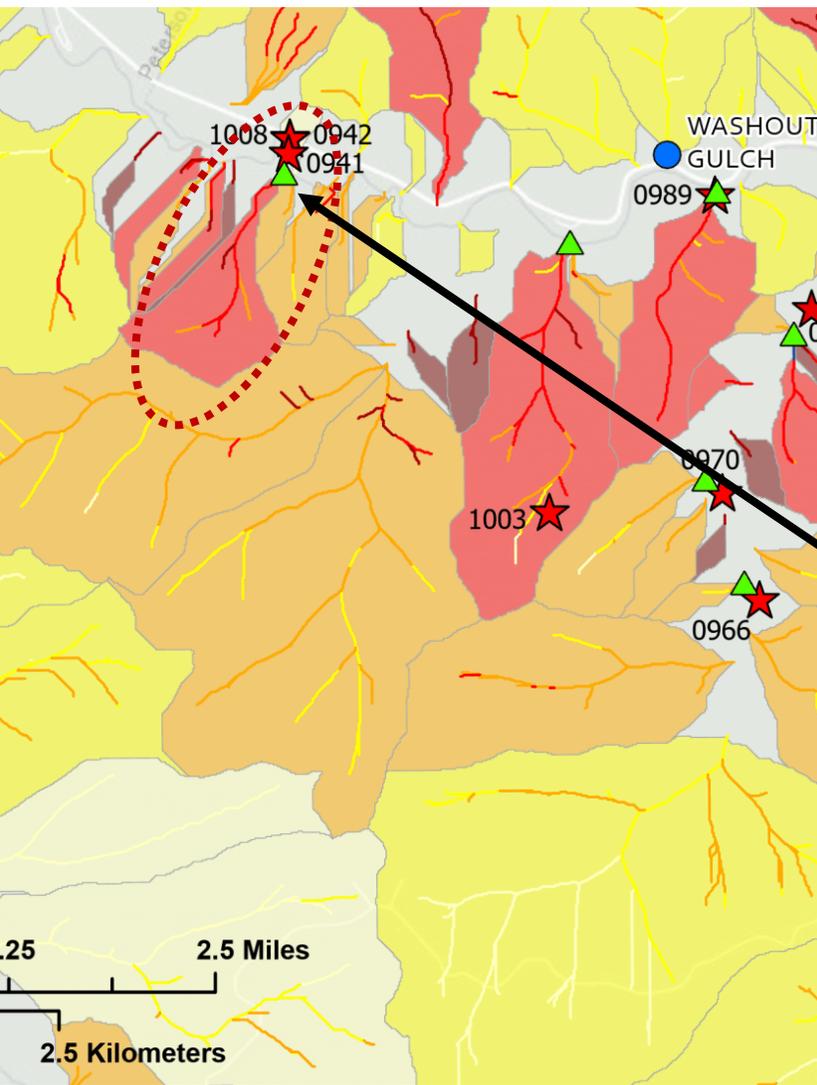
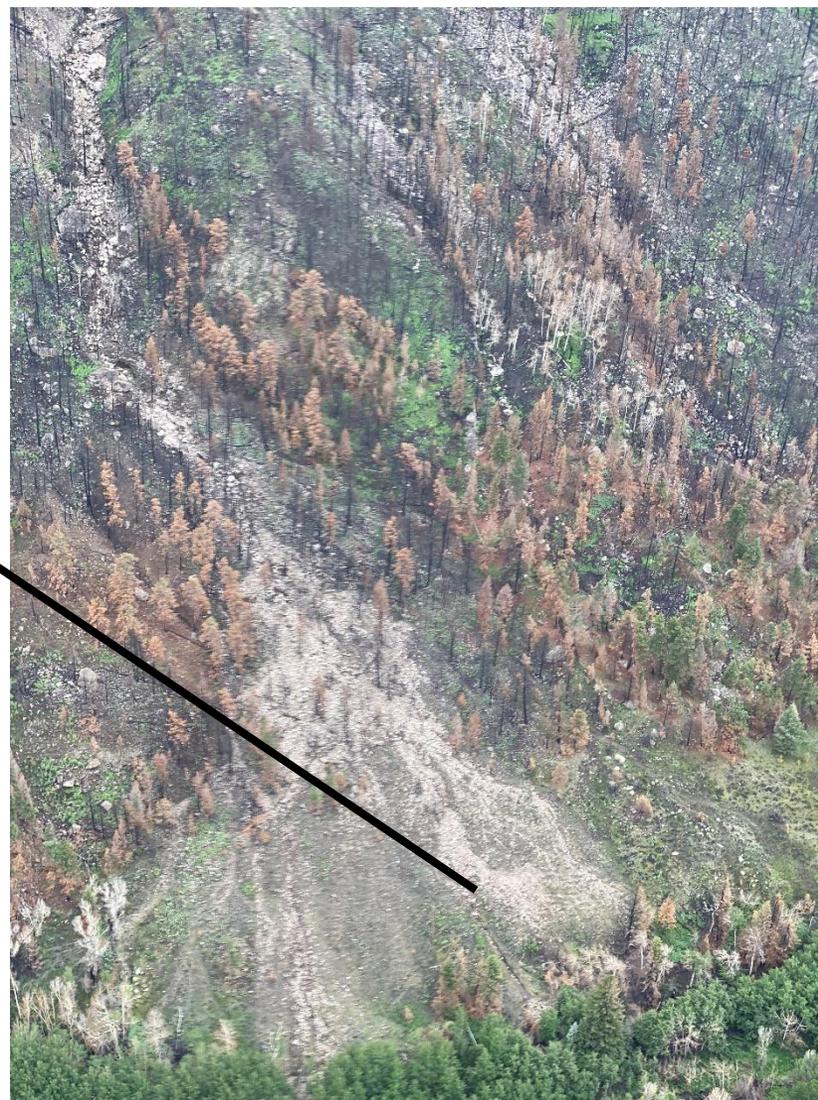
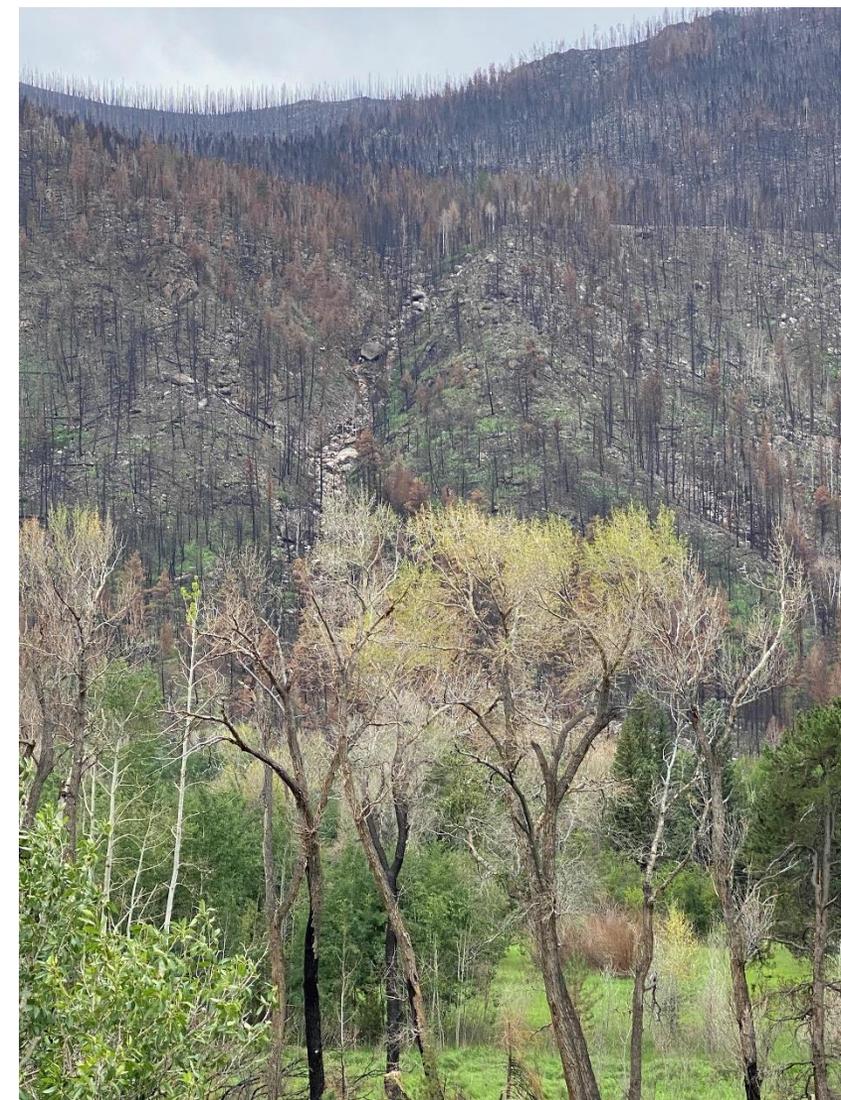
Obs. #	Segment ID	Obs. I15 (mm/hr)	Likelihood (%)	Volume (m <sup>3</sup> )
1008, 0941	4893	37	94	15,000
