Dam Siting

Larimer County NISP 1041 Hearing

August 24, 2020

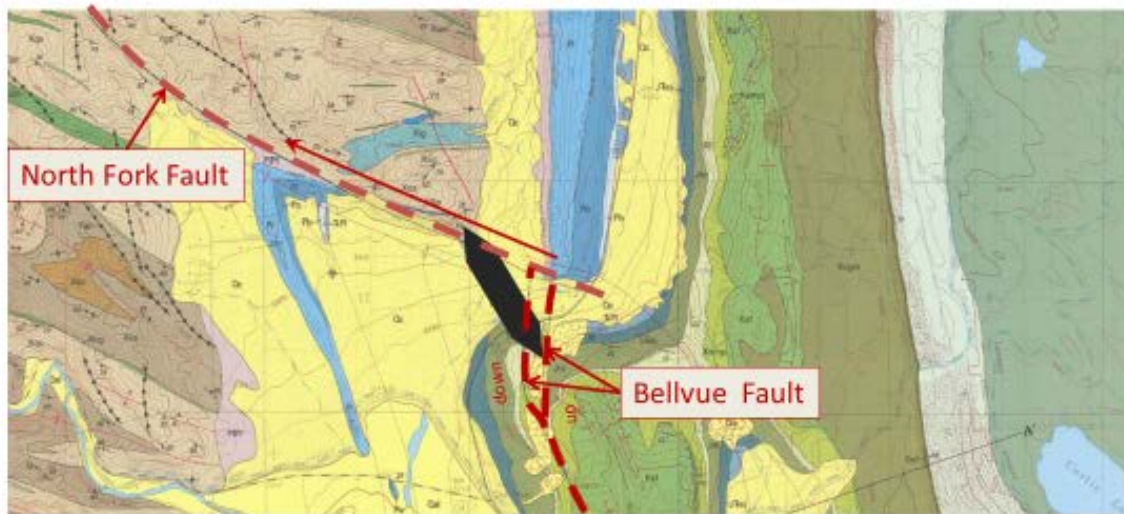
GEOLOGIC MAP OF THE LAPORTE QUADRANGLE, LARIMER COUNTY, COLORADO

Two major faults with large displacement pass under the proposed dam site

North Fork and Bellvue Faults

Leakage through rubblized rock along faults seems likely to lead to dissolution of soluble limestone and gypsum beds. Underflow far more severe than that observed at the North Horsetooth Dam seems certain. No discussion of the faults below the proposed dam are presented in the EIS.

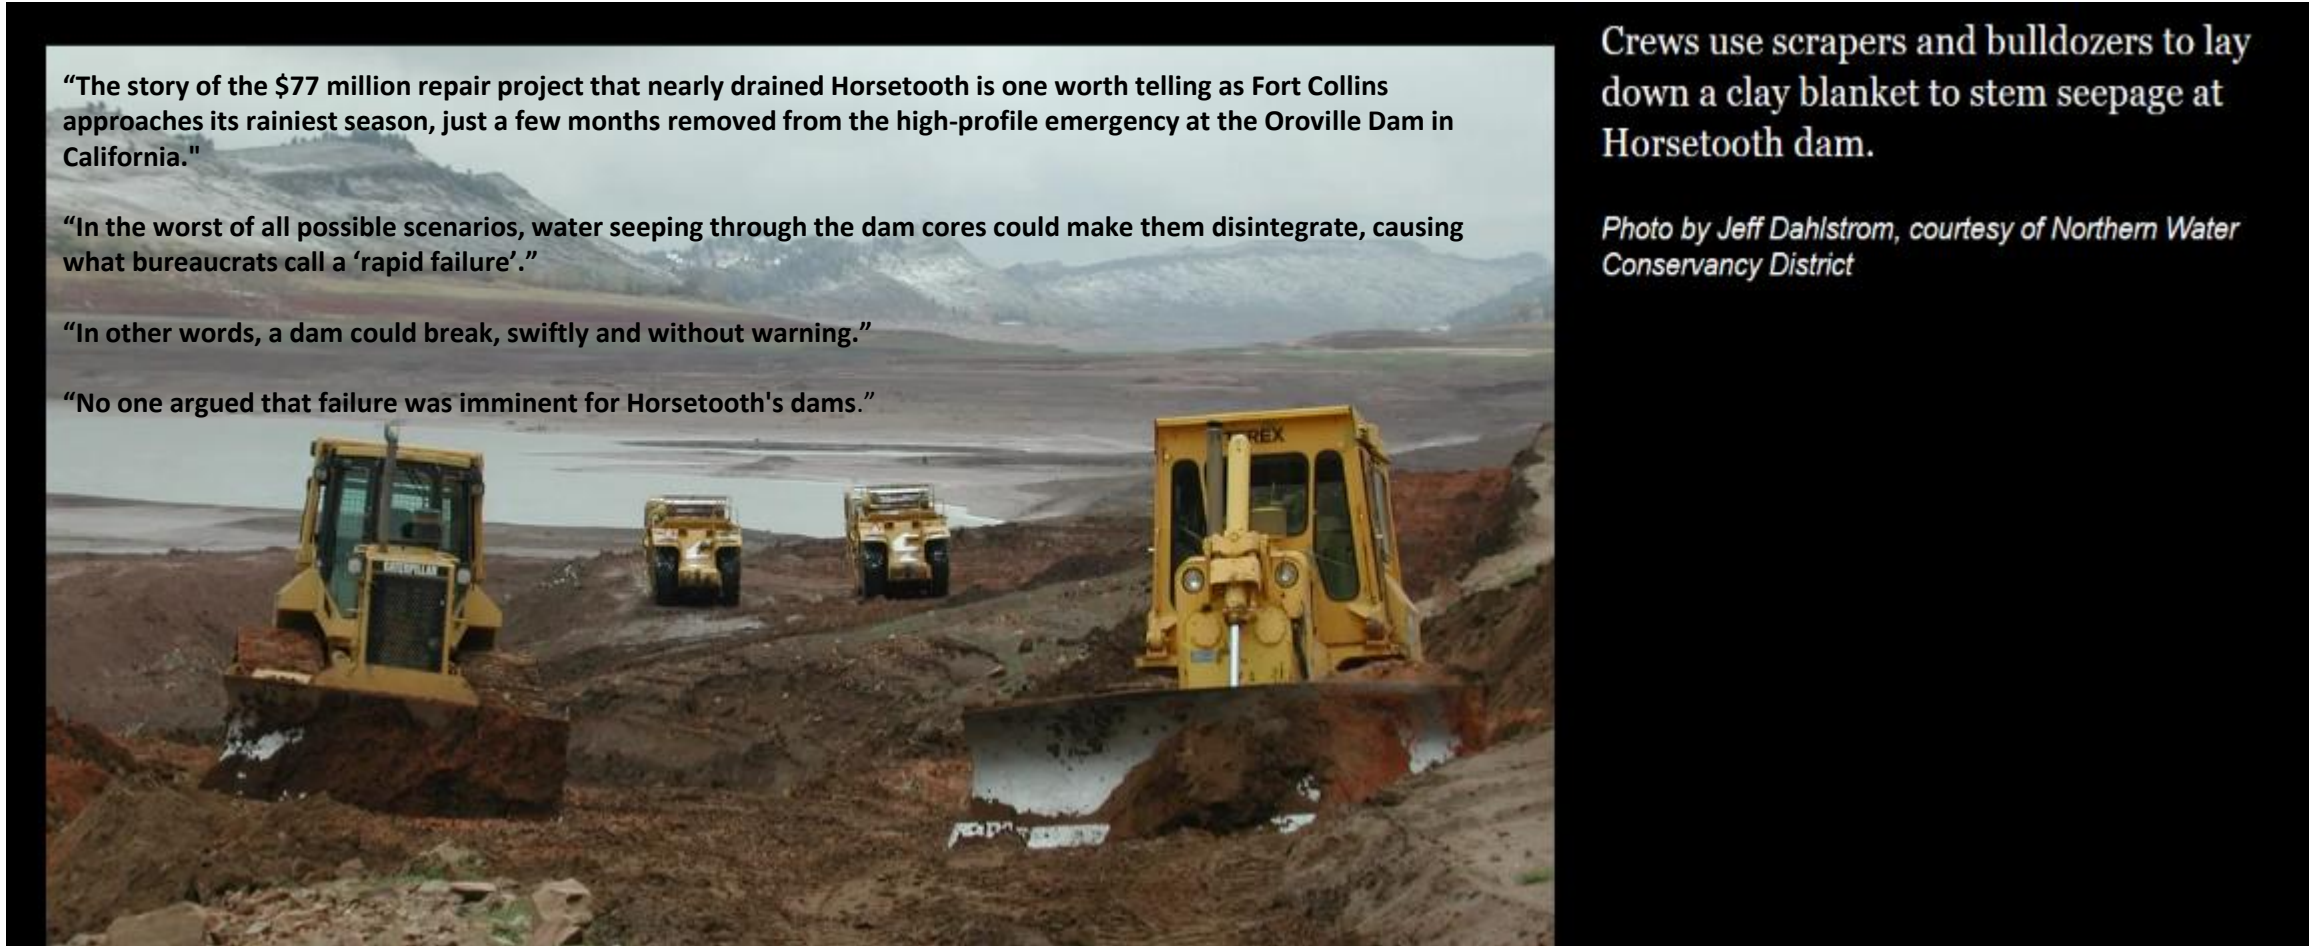
Crews use scrapers and bulldozers to lay down a clay blanket to stem seepage at Horsetooth dam.

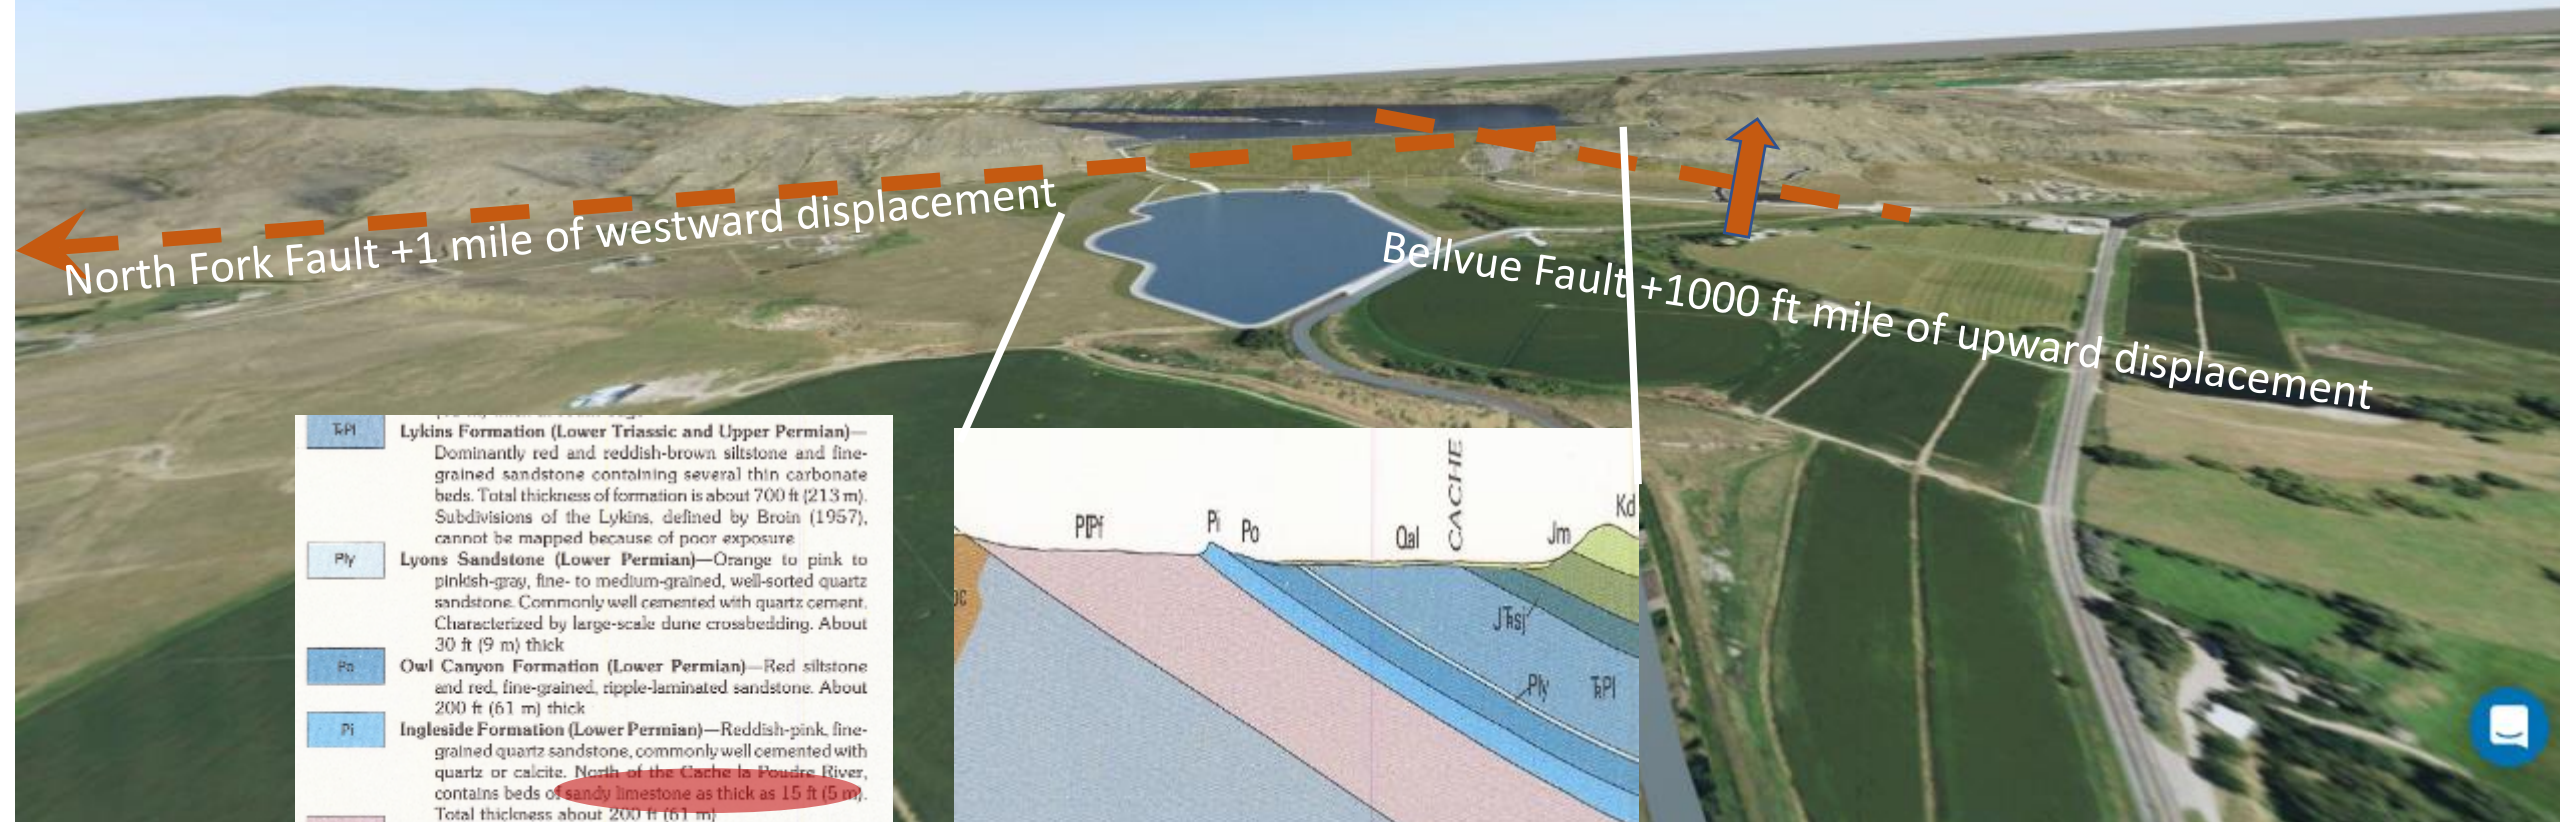
TrP1	Lykins Formation (Lower Triassic and Upper Permian) —Dominantly red and reddish-brown siltstone and fine-grained sandstone containing several thin carbonate beds. Total thickness of formation is about 700 ft (213 m). Subdivisions of the Lykins, defined by Broin (1957), cannot be mapped because of poor exposure
Ply	Lyons Sandstone (Lower Permian) —Orange to pink to pinkish-gray, fine- to medium-grained, well-sorted quartz sandstone. Commonly well cemented with quartz cement. Characterized by large-scale dune crossbedding. About 30 ft (9 m) thick
Po	Owl Canyon Formation (Lower Permian) —Red siltstone and red, fine-grained, ripple-laminated sandstone. About 200 ft (61 m) thick
Pi	Ingleside Formation (Lower Permian) —Reddish-pink, fine-grained quartz sandstone, commonly well cemented with quartz or calcite. North of the Cache la Poudre River, contains beds of sandy limestone as thick as 15 ft (5 m). Total thickness about 200 ft (61 m)

PP1	Fountain Formation (Lower Permian and Upper and Middle Pennsylvanian) —Reddish-brown to purplish-gray arkosic conglomerate, medium- to coarse-grained feldspathic sandstone, and dark-reddish-brown siltstone and shale. Minor thin limestone. Total thickness about 800 ft (244 m)

The sedimentary layers underlying the site include permeable conglomerates (ancient gravel deposits) as well as soluble carbonate and gypsum-rich layers. Large seepage losses are likely and there is a risk of dam failure....
