**Cameron Peak Fire Risk  
Assessment**

Final Report

Stantec Consulting Services Inc.  
on behalf of Synergy Disaster Recovery

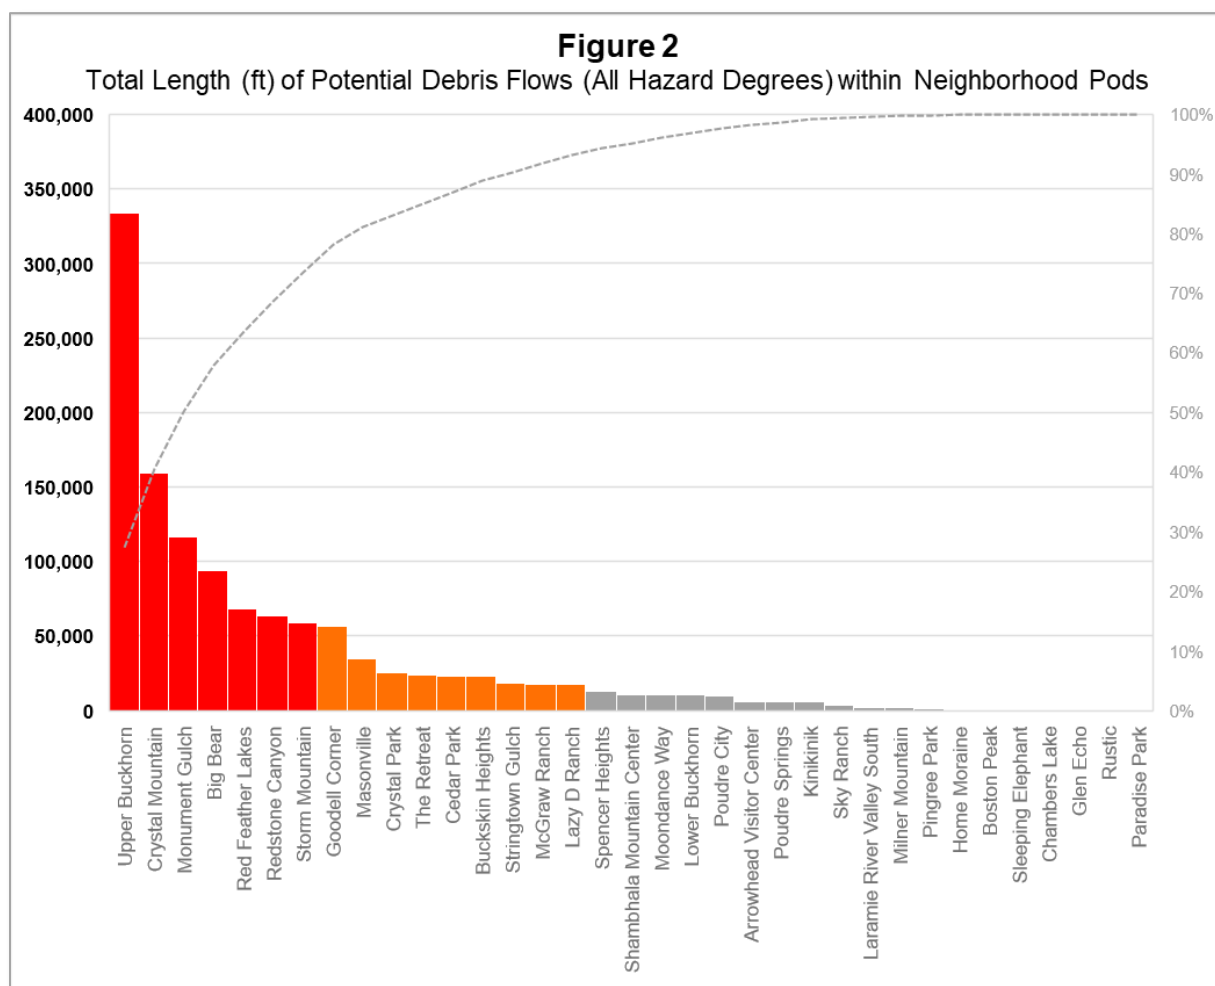
This examination of neighborhood by debris flow potential resulted in the identification of 8 neighborhoods that have potential to experience significant debris flows (>50,00 feet total) within the neighborhood pod. These neighborhoods include the following: Big Bear, Crystal Mountain, Goodell Corner, Monument Gulch, Red Feather Lakes, Redstone Canyon, Storm Mountain, and Upper Buckhorn. A histogram depicting the total length of debris flows by neighborhood pod is presented below (**Figure 2**). Neighborhoods represented by red bars represent those pods in the 20<sup>th</sup> percentile. Neighborhoods represented by orange bars represent those pods in the top 40<sup>th</sup> percentile. The gray bars represent neighborhoods below the 40<sup>th</sup> percentile.

Neighborhoods were assessed to determine the total length of potential debris flows (length in feet) across all debris flow severities [High, Moderate, Low, or None] within each of the 35 neighborhood polygons. In addition to analyzing by hazard class, the sum of all hazard classes was calculated for each neighborhood.

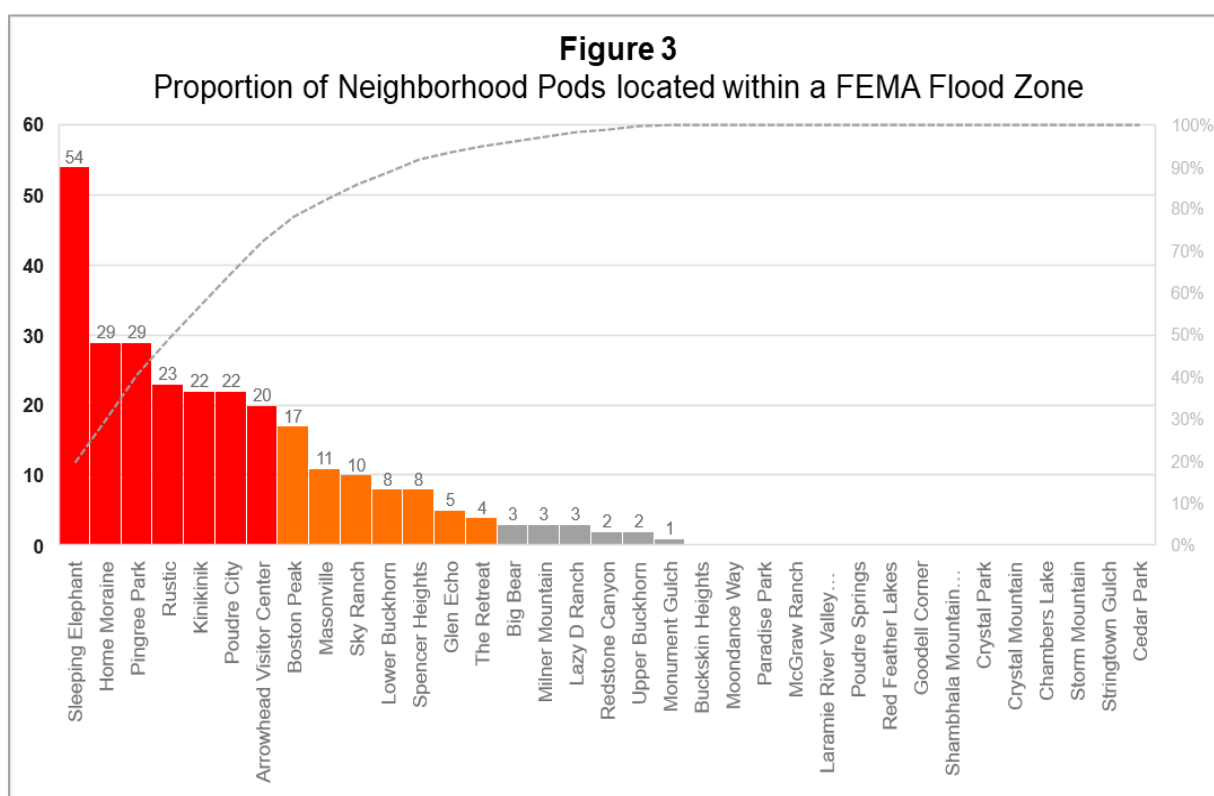
This examination of neighborhood by FEMA Flood Zone resulted in the identification of 6 neighborhoods having a significant proportion (>20%) of the neighborhood located within a mapped flood zone. These six neighborhoods include the following: Home Moraine, Kiniklinik, Pingree Park, Poudre City, Rustic, and Sleeping Elephant. A histogram depicting the proportion of neighborhood pods located within a FEMA flood zone is presented below (**Figure 3**). Neighborhoods represented by red bars represent those pods in the 20<sup>th</sup> percentile. Neighborhoods represented by orange bars represent those pods in the top 40<sup>th</sup> percentile. The gray bars represent neighborhoods below the 40<sup>th</sup> percentile.

Neighborhoods were assessed to determine the proportion of each neighborhood within a FEMA flood zone. This includes the 100-year Flood Zone, the 100-year Floodway, and the 500-year Flood Zone. In

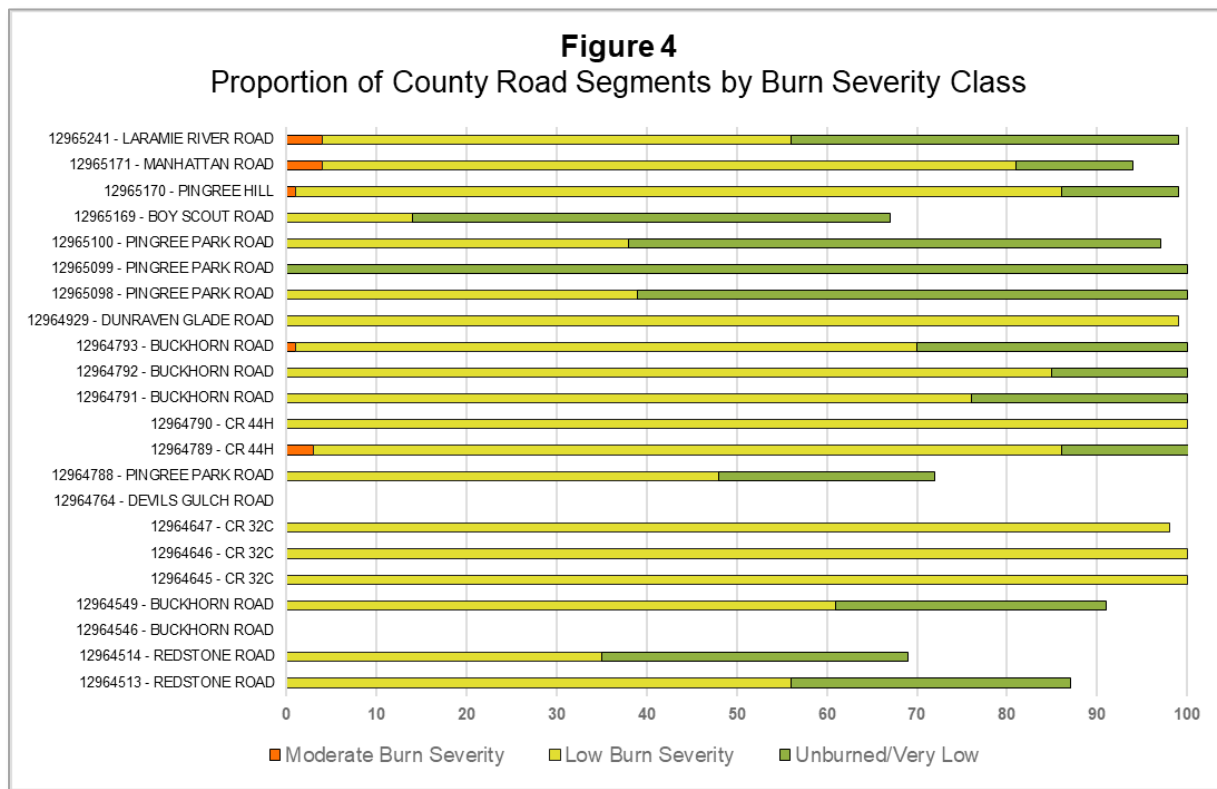
The assessment of County Roads and post-fire burn severity resulted in the identification of 5 County Roads that experienced Moderate burn severity. These road segments include the following: Buckhorn Road [CR 44H] (Segment ID 12964789), Buckhorn Road [CR 44H] (Segment ID 12964793), Pingree Hill Road [CR69] (Segment ID 12965170), Manhattan Road [CR 69] (Segment ID 12965171), and Laramie River Road [CR 103] (Segment ID 12965241). No County Road segments occurred within a High Severity Burn mapping unit. Most (19 of 22 segments examined) County Road segments within the burn perimeter occur in areas of Low burn severity. A stacked bar chart depicting the percentage of County Road Segments within each burn severity class is presented below (**Figure 4**).

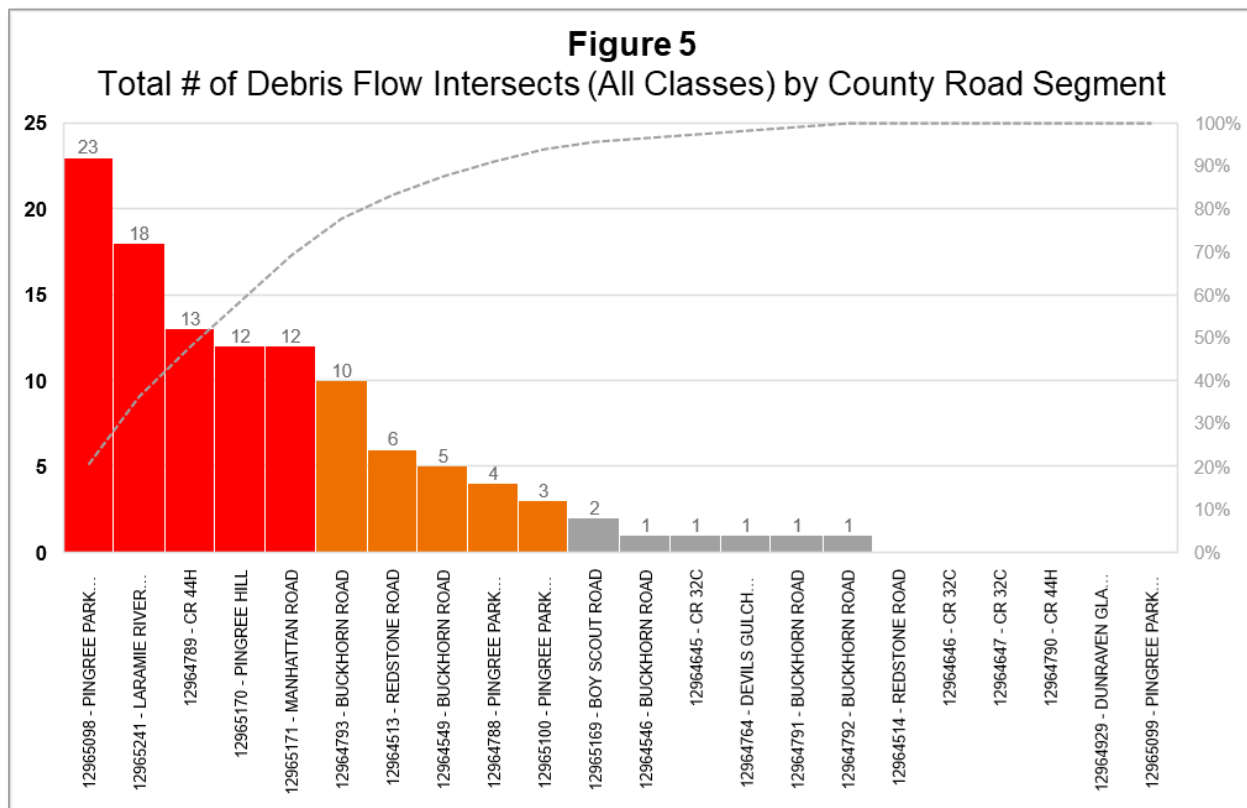
County Roads were assessed to determine the total number of potential debris flows intersects across all severities [High, Moderate, Low, or None] with each of the 22 road segments. In addition to analyzing by each hazard class individually, the sum of debris flow intersections for all hazard classes was calculated for each road segment.

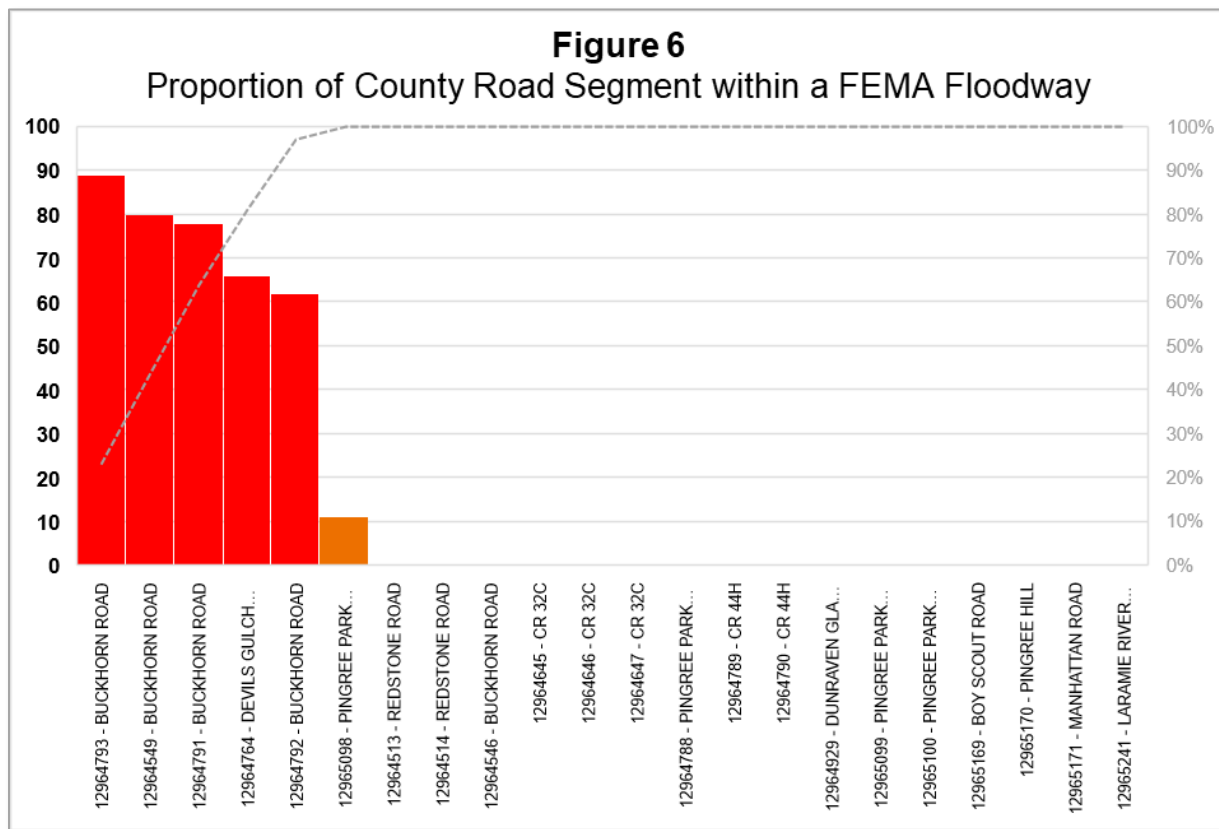
This examination of County Road by FEMA Flood Zone resulted in the identification of 6 road segments having a proportion of their length in a 100-year Flood Zone, or a significant proportion of their length (>50%) in any hazard class. These six road segments include the following: Buckhorn Road [CR 44H] (Segment ID 12964549), Devils Gulch Road [CR 43] (Segment ID 12964764), Buckhorn Road [CR 44H] (Segment ID 12964791), Buckhorn Road [CR 44H] (Segment ID 12964792), Buckhorn Road [CR 44H] (Segment ID 12964793), and Pingree Park Road [CR 63E] (Segment 12965098). A histogram depicting the proportion of County Road segments located within a FEMA flood zone is presented below (**Figure 6**). Road segments represented by red bars represent those pods in the 20<sup>th</sup> percentile. Road segments represented by orange bars represent those pods in the top 40<sup>th</sup> percentile. The gray bars represent road segments below the 40<sup>th</sup> percentile.

County Roads were assessed to determine the proportion of each road segment within a FEMA flood zone. This includes the 100-year Flood Zone, the 100-year Floodway, and the 500-year Flood Zone. In addition to analyzing the road segments by each individual hazard class, the sum percentage of each road segment within all classes was calculated as a summary statistic.
